Agricultural Experiment Station

BULLETIN NO. 143

ECONOMY OF THE ROUND DAIRY BARN

FULL SPECIFICATIONS AND DETAILED COST AND CONSTRUCTION OF
THE NEW SIXTY-FOOT CIRCULAR DAIRY BARN AT THE UNI-
VERSITY. SAVING OF ROUND OVER RECTANGULAR
BARN. NOTES ON SEVERAL ROUND BARN
ON DAIRY FARMS.*

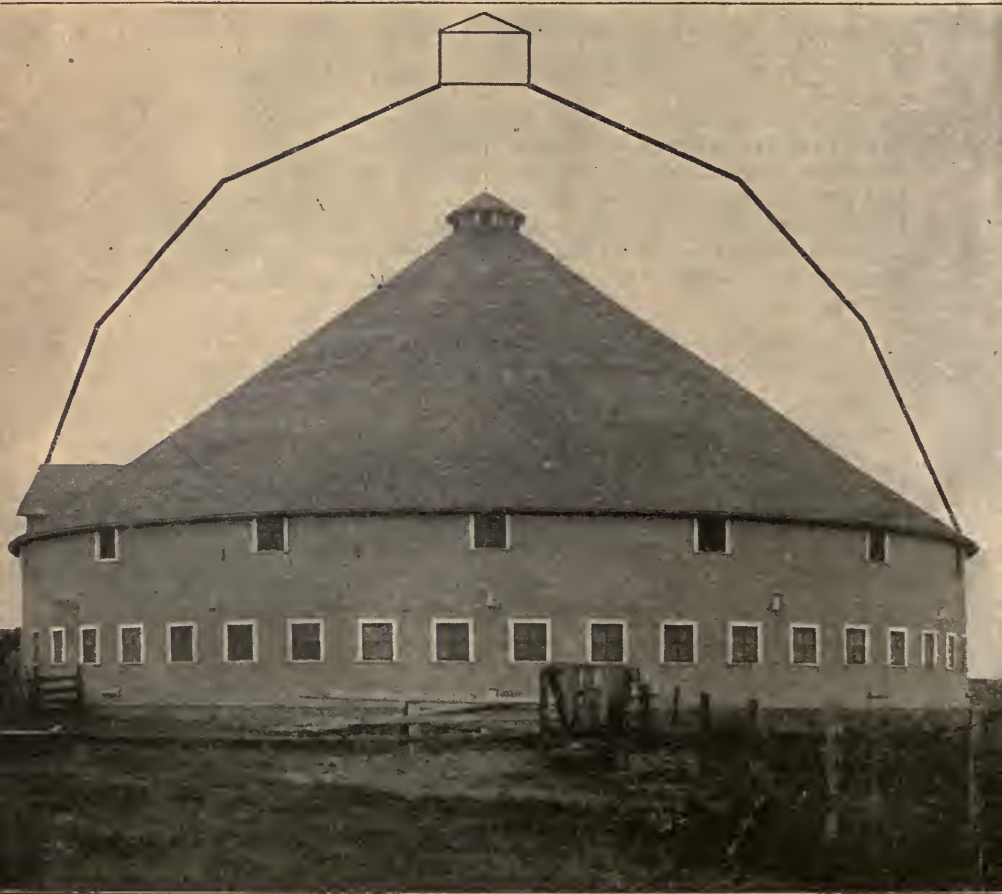
FIG. 1. BARN No. 5. 100 FEET IN DIAMETER, SCALE 20 FEET TO ONE INCH; SHOWING INCREASED MOW CAPACITY GIVEN BY SELF-SUPPORTING ROOF.

The difficulty with most round barns that have been built, thus far, is that they do not have a self-supporting roof, and consequently lose many of the advantages of a properly constructed round barn. This is the principal reason why round barns have not become more popular. A straight roof necessarily requires many supports in the barn below. These are both costly and inconvenient, and make the roof no stronger than a dome-shaped, self-supporting roof which nearly doubles the capacity of the mow. See Fig. (1).

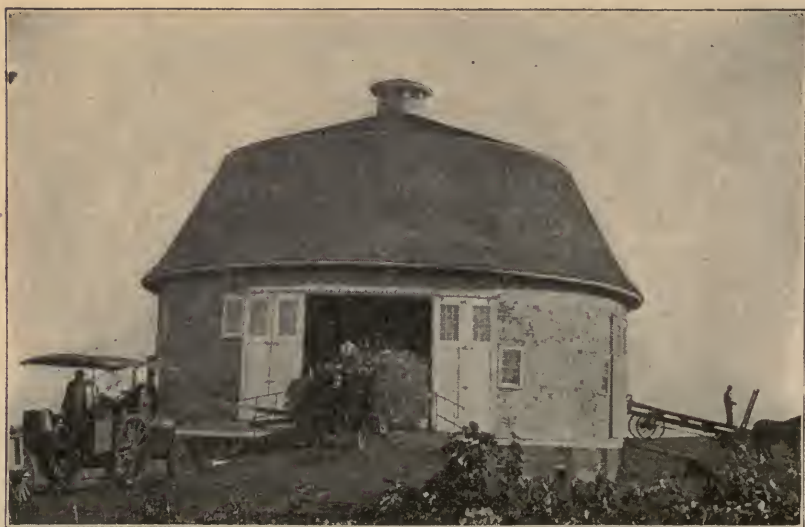
FIG. 2. FILLING THE SILO.

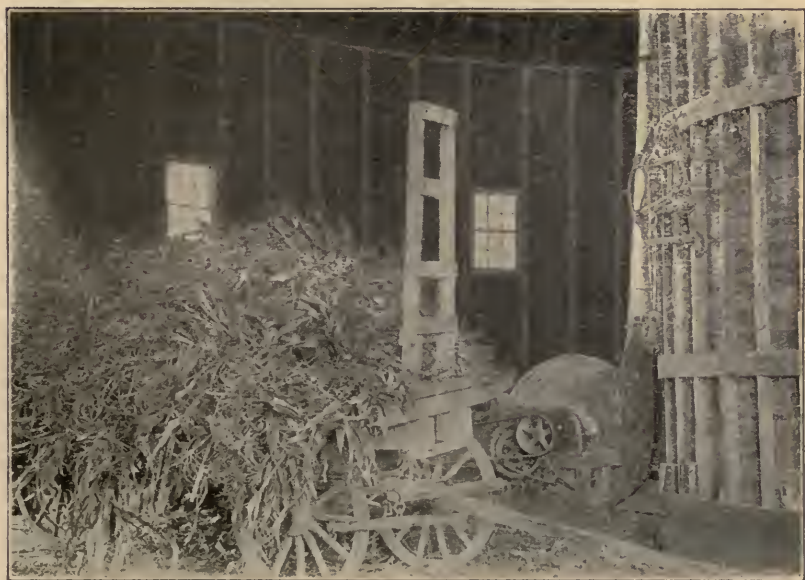
FIG. 3. INTERIOR OF BARN, SECOND FLOOR, SHOWING SILO AND LOCATION OF ENSILAGE CUTTER. (TEAM UNHITCHED TO SHOW CUTTER.)

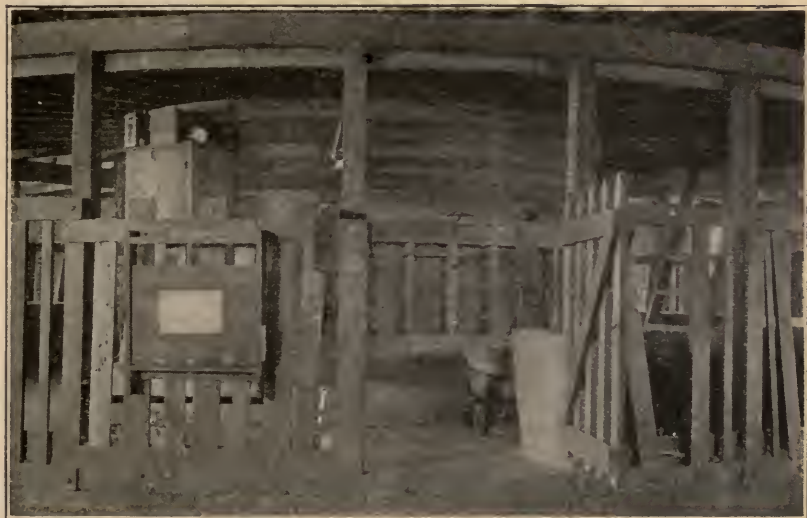
FIG. 5. IN COW STABLE, SHOWING SILO AND FEED ALLEY IN CENTER OF BARN; STANCHIONS ON RIGHT, MILK SCALES AND RECORD SHEET ON LEFT.

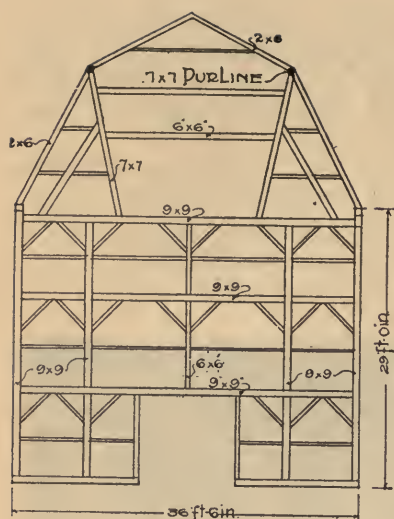
FIG. 6. SHOWING CONSTRUCTION OF MORTISE FRAME BARN, END VIEW.

Figures 6 to 9 are side and end views, showing the detail construction and size of the timbers of the plank frame and mortise frame barns here figured. The detailed figures of the lumber bills for each of these barns were carefully worked out, but are too voluminous for publication here. The total number of feet of each kind of lumber required is given in Tables 1A and 1B. Since the proportion of the different kinds of lumber and shingles varied for the different barns, to draw an exact comparison it was

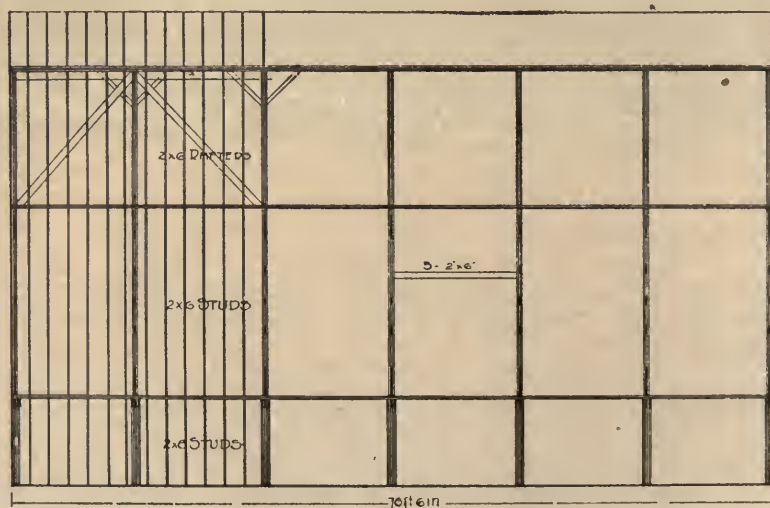
FIG. 7. SHOWING CONSTRUCTION OF PLANK FRAME BARN, SIDE VIEW.

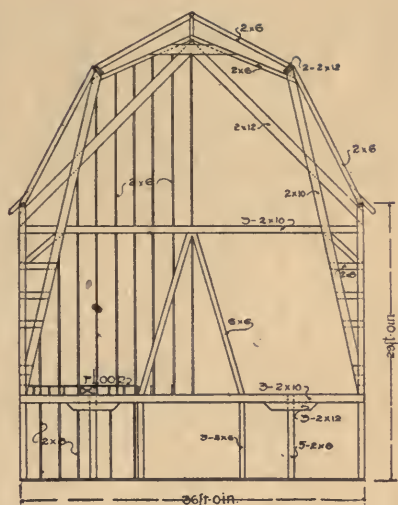
FIG. 8. SHOWING CONSTRUCTION OF PLANK FRAME BARN, END VIEW.

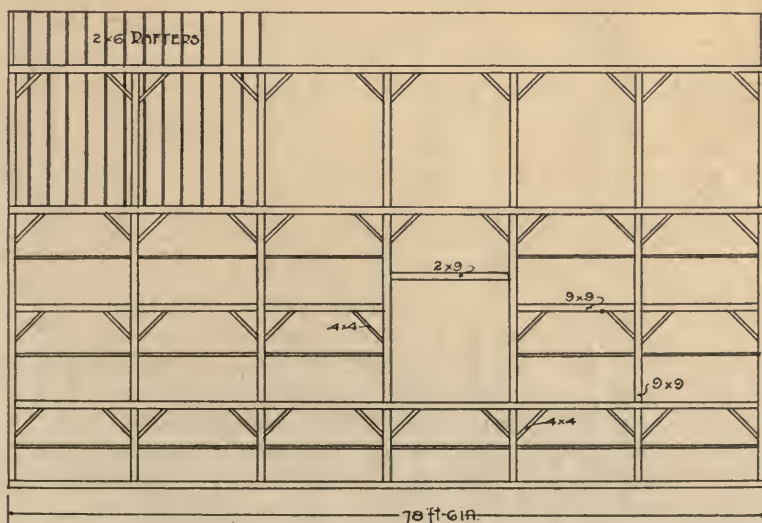
FIG. 9. SHOWING CONSTRUCTION OF MORTISE FRAME BARN, SIDE VIEW.

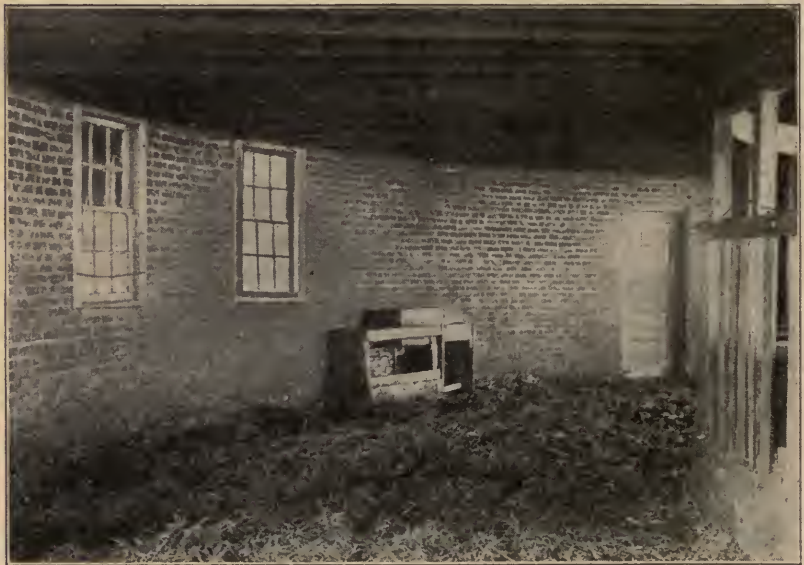
FIG. 10. INTERIOR OF COW STABLE, SHOWING WATER TROUGH WITH FLOAT VALVE, SALT BOX, AND DOOR INTO DAIRY.

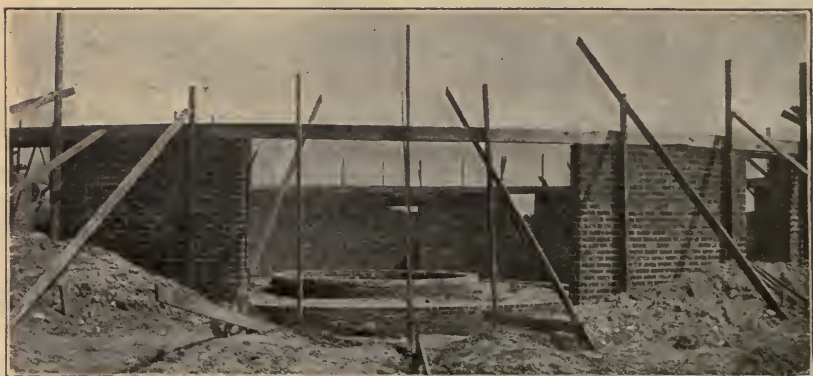
FIG. 12. FIRST STORY WALL, AND FOUNDATION FOR SILO, FEED ALLEY, AND MANGER; SILL IN PLACE, READY FOR JOISTS AND STUDS.

The footing for the foundation is 18 inches wide. A ten-inch brick wall was carried up nine feet above the stable floor. This wall contains a 2-inch air space to prevent moisture from condensing on the inner wall and making the barn damp. This is an im-

The foundation for the manger and feed alley is built up 2 feet above the stable floor. The foundation for the silo extends 4 feet below the stable floor and is continued 9 inches above the floor in the feed alley. This silo wall, together with the foundation under the manger, forms the foundation for the center supports of the barn. Fig. 12 shows the foundation completed.

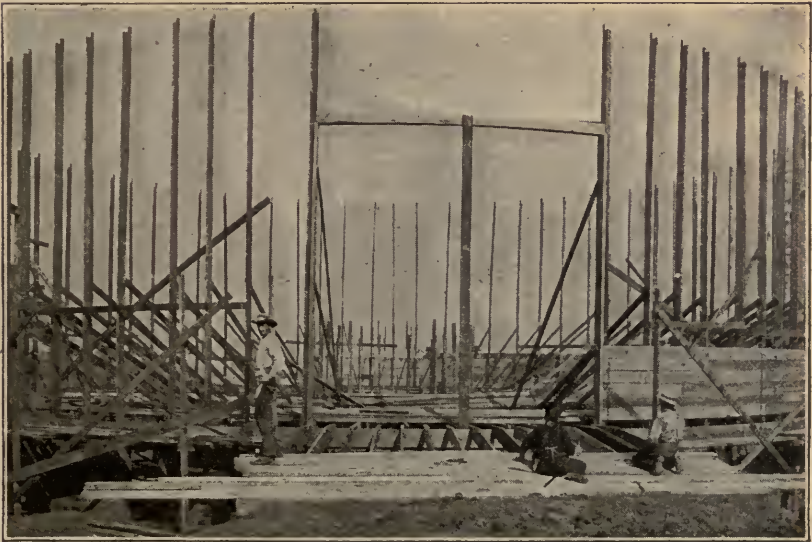
FIG. 13. SHOWING TEMPORARY BRACING TO HOLD STUDS IN PLACE WHILE SHIP LAP CEILING IS NAILED ON.

The studs, which are 2x6s, 20 feet long, were then placed on the sill, about 2 feet 6 inches apart, being as evenly spaced between the windows as possible, and temporarily braced, as shown in Fig. 13, until the 8-inch ship lap ceiling could be nailed on the outside. This was carried up 5 feet to the second scaffold, and then covered

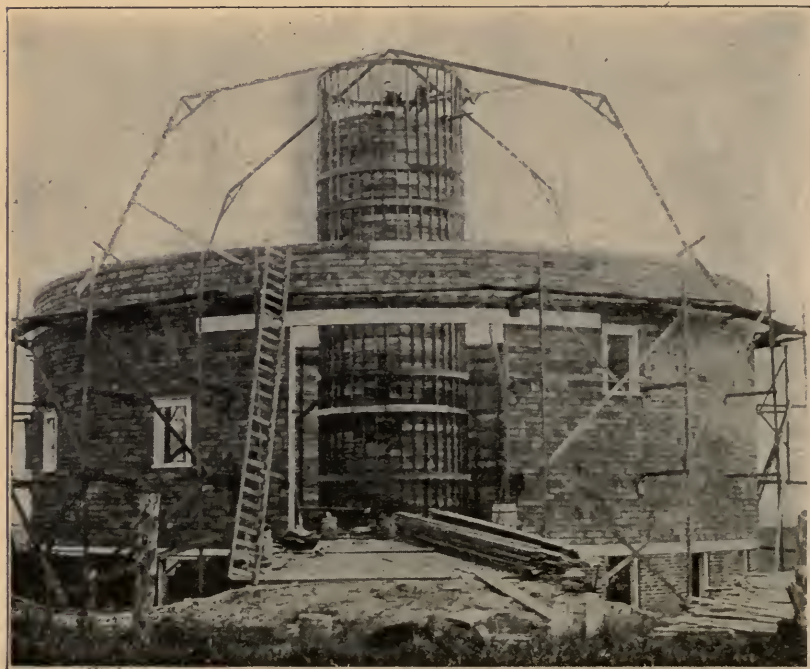
FIG. 14. SHOWING HEIGHT AND CONSTRUCTION OF SILO, SIDING COMPLETED, AND FOUR MAIN RAFTERS IN PLACE.

The silo was completed, as before described. The rafters, which were framed on the ground, were then erected, as shown in Fig. 14, the first eight going to the center of the roof, and the

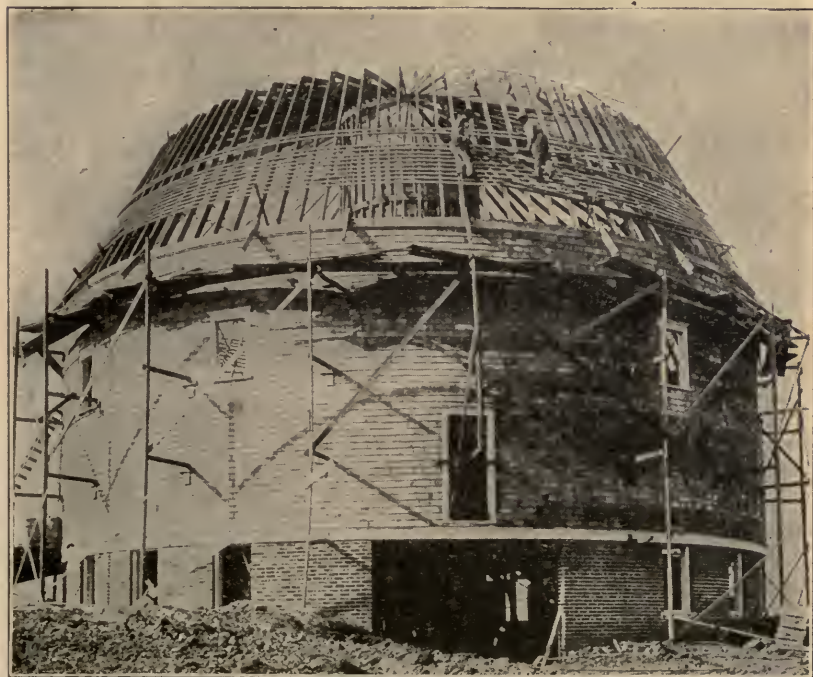
FIG. 15. SHOWING ALL RAFTERS IN PLACE AND METHOD OF SHEATHING ROOF.

remaining ones were cut to rest on the plate of the silo. There are 64 framed rafters, and these are the only ones in the upper section of the roof. At the break in the roof, a header is cut in between the framed rafters, and in the lower section a rafter is placed between these, thus making twice as many rafters in the lower section of the roof as in the upper section. After the rafters were all in place and temporarily braced, the 1x2-inch sheathing was put on, as shown in Fig 15, and the shingles, which were the best 5/2

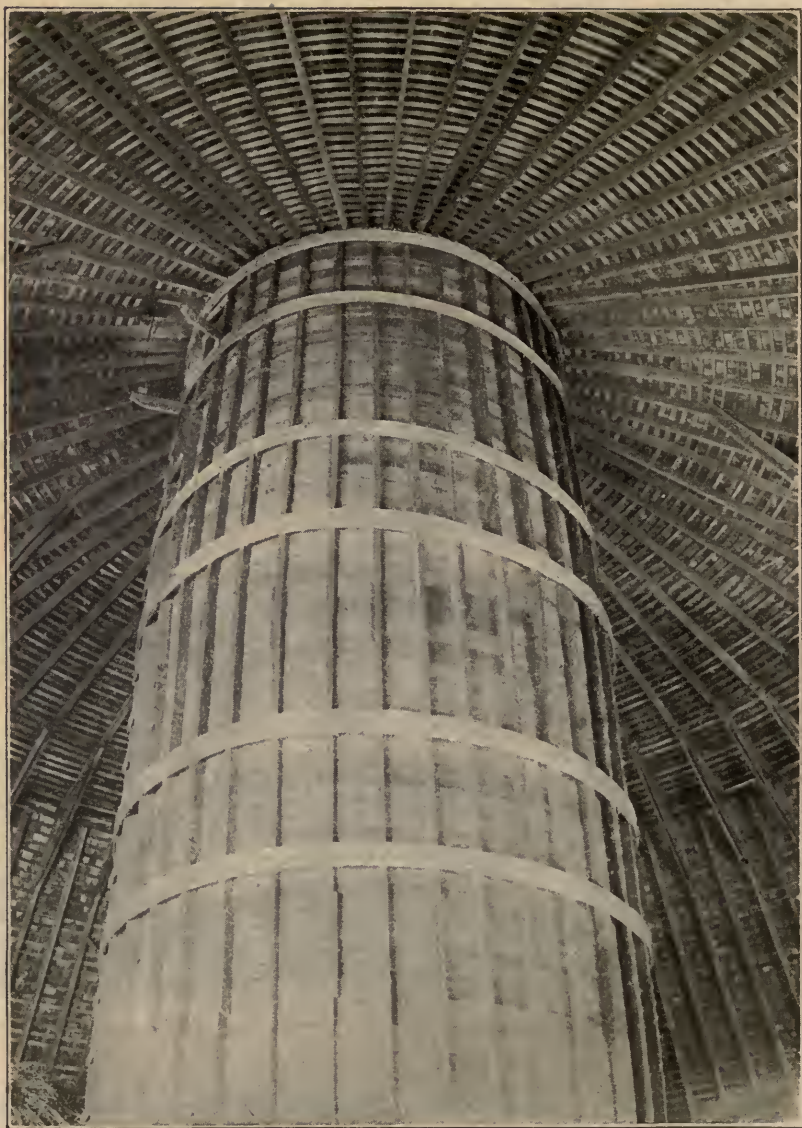
FIG. 16. SHOWING HEIGHT OF SILO, CAPACITY OF BARN, AND CONSTRUCTION OF ROOF.

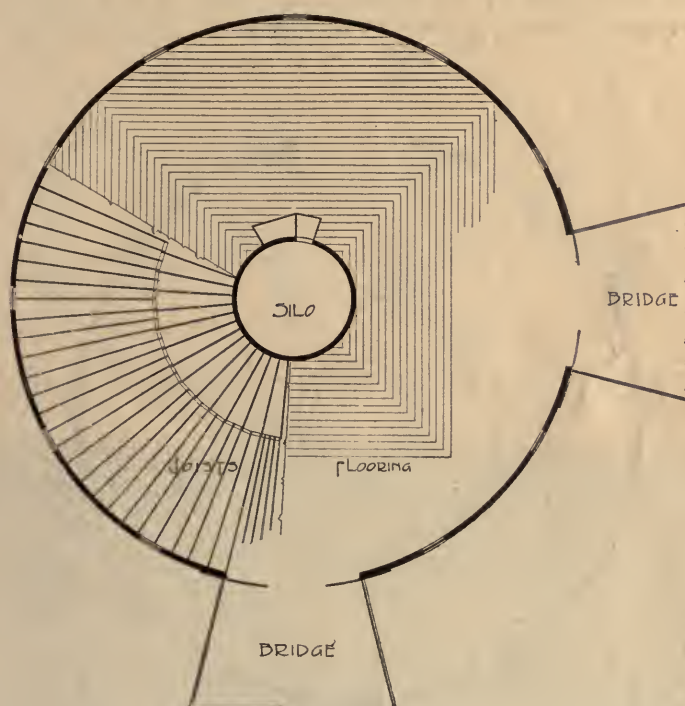
FIG. 17. SHOWING ARRANGEMENT OF JOISTS AND HOW THE FLOOR IS LAID.

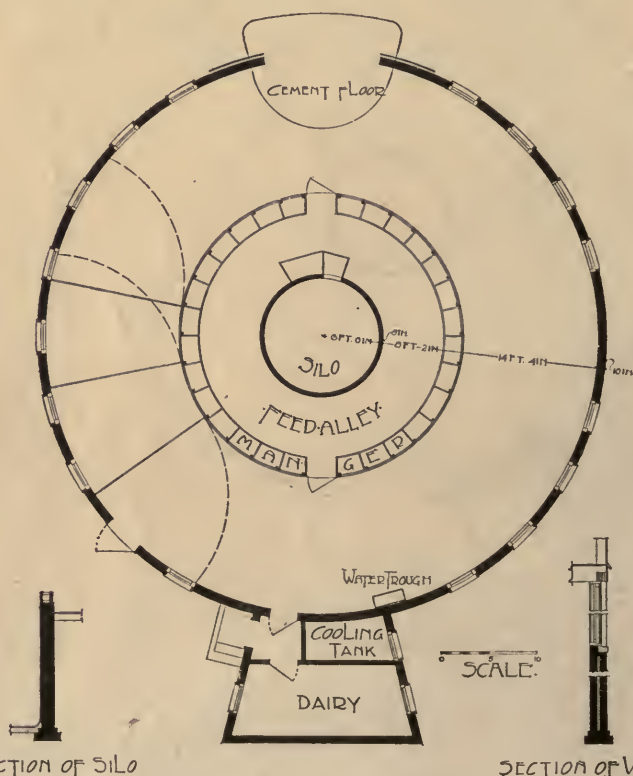
FIG. 18. SHOWING PRESENT ARRANGEMENT OF COW STABLE. THERE ARE STANCHIONS AND MANGERS FOR 28 COWS, AND 2200 SQ. FT. OF FLOOR SPACE IN WHICH THE COWS CAN RUN LOOSE. THE GATES ARE SWUNG INTO THE PRESENT POSITION WHEN BOX STALLS ARE NEEDED.

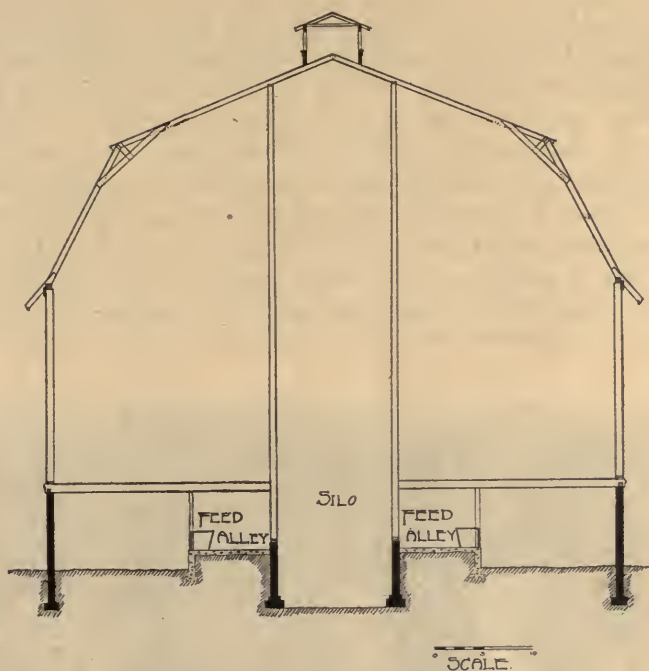
FIG. 19. SHOWING CROSS SECTION OF 60-FOOT ROUND BARN.

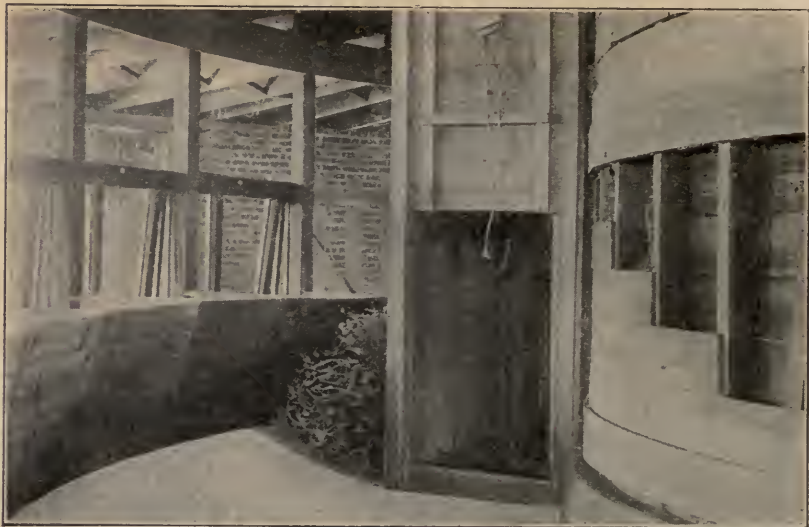
FIG. 22. FEED ALLEY, SHOWING COMBINED HAY CHUTE AND VENTILATOR. A DOOR ON THE SIDE WHICH IS HINGED AT THE BOTTOM, 3 FEET FROM THE FLOOR, IS LET IN TOWARD THE SILO, SLIDING THE HAY ONTO THE FLOOR. IN HOT WEATHER THIS OPENING TAKES THE HEAT OUT OF THE BARN; DURING THE WINTER THIS DOOR IS KEPT CLOSED AND THE VENTILATION IS REGULATED BY RAISING THE SLIDE, AS SHOWN IN THE CUT.

The system of ventilation is the "King." To economize space and lumber, the hay chute is used for a ventilator. This chute, which extends to the cupola, is $2\frac{1}{4} \times 3\frac{1}{2}$ feet, having a cross section area of 8 sq. ft., which, with a good draft, is sufficient for 40 cows. In order that this combination of ventilator and hay

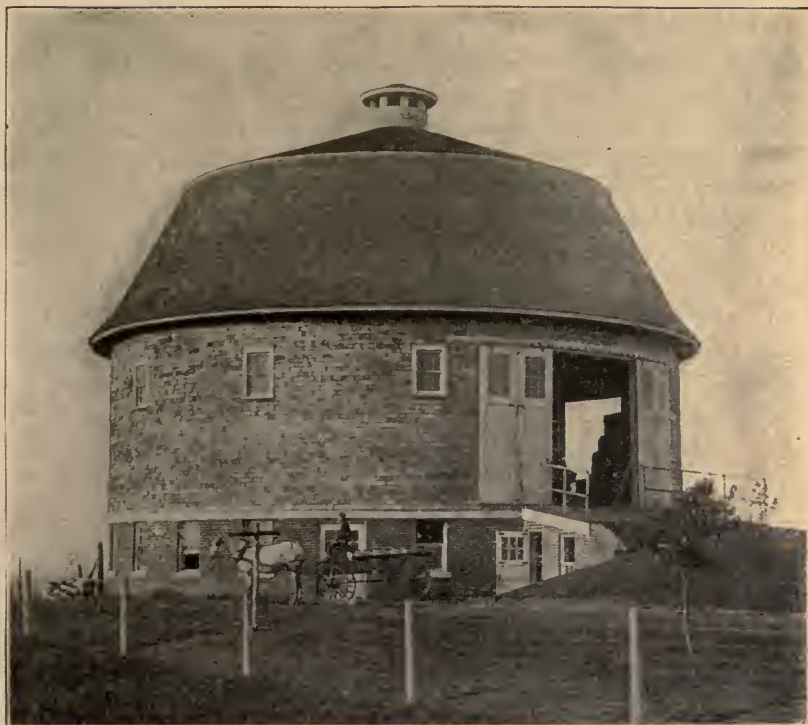
FIG. 23. NORTHEAST VIEW, SHOWING DAIRY UNDER DRIVEWAY. THE BARN IS ON THE SAME SCALE AS THE DRAWING ON PAGE 28.

To economize space, the milk room, 12x16 feet, is located under the north driveway. The brick walls under the drive form the sides of this room, and the floor of the drive, which is made of 2x6s grooved on both edges, forms the roof. The grooves in the flooring were filled with white lead, and a wooden strip, fitted to fill the grooves of both planks, was driven in, forming a water-tight floor. This floor was covered with hot tar and sand $\frac{1}{2}$ inch thick. The milk room is plastered on the inside, the plaster being applied directly to the brick walls, excepting in the case of the ceil-

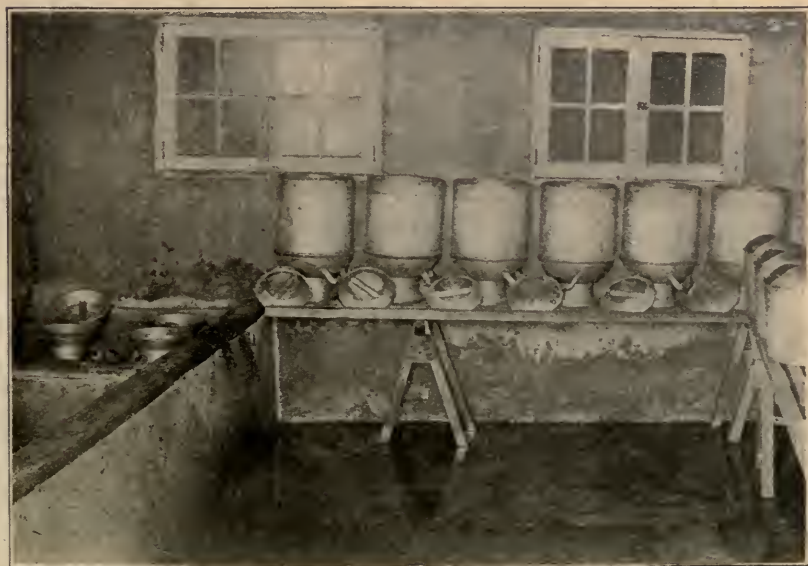
FIG. 24. INTERIOR OF DAIRY; COOLING TANK ON LEFT.

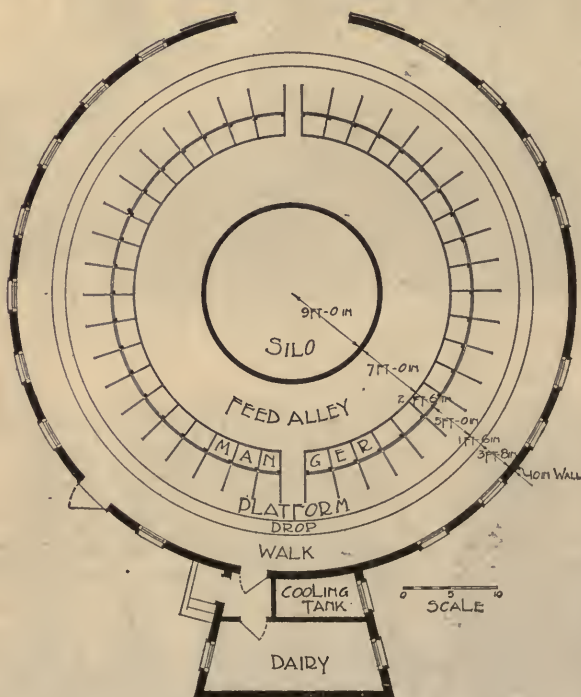
FIG. 25. SHOWING HOW THIS 60-FOOT BARN MAY BE ARRANGED TO ACCOMMODATE 40 COWS IN STALLS. TO SUPPLY THIS SIZED HERD AND THE NECESSARY YOUNG STOCK WITH SILAGE FOR EIGHT MONTHS WOULD REQUIRE A 370-TON SILO, OR ONE 18 FEET IN DIAMETER AND 56 FEET DEEP; WITH A SEVEN-FOOT FEED ALLEY AND A 2½-FOOT MANGER, THE CIRCLE AT THE STANCHIONS WOULD BE 38 FEET IN DIAMETER, OR 119⅓ FEET IN CIRCUMFERENCE; ALLOWING 4¼ FEET FOR TWO PASSAGE WAYS, THE STALLS WOULD BE 2 FEET 10½ INCHES WIDE AT THE STANCHION, AND 3 FEET 6 INCHES AT THE DROP.

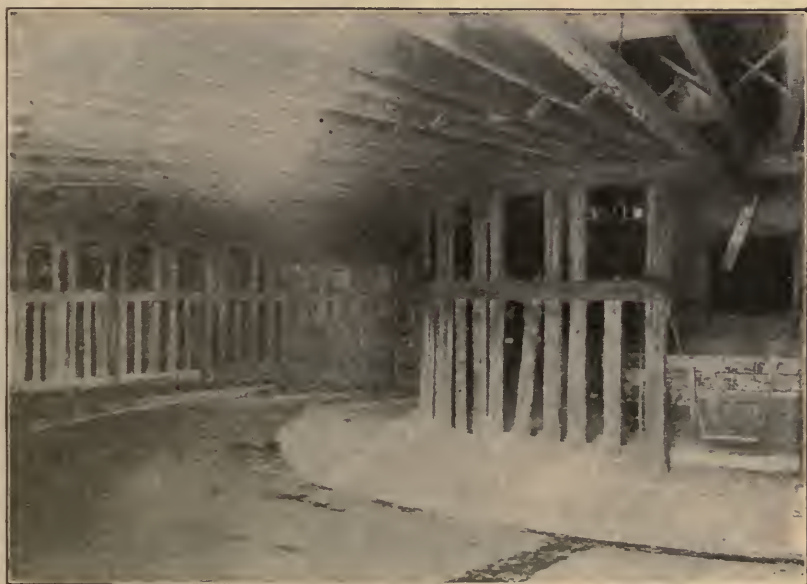
FIG. 27. INTERIOR OF BARN NO. 2, SHOWING TWO ROWS OF STANCHIONS AND DRIVE BEHIND COWS WHICH IS USED IN CLEANING BARN; SILO ON RIGHT.

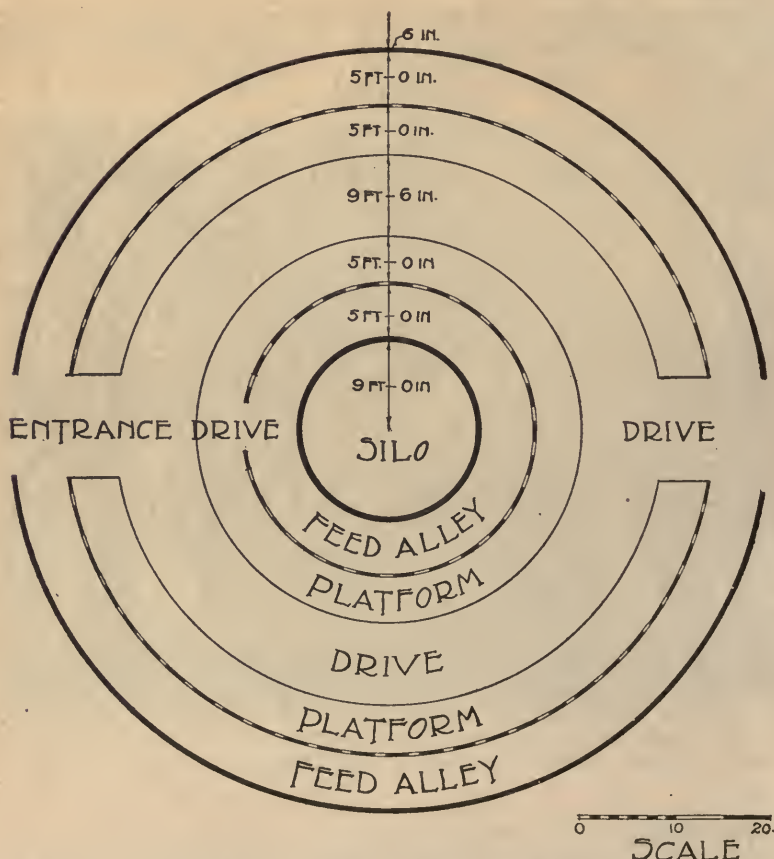
FIG. 28. ARRANGEMENT OF COW STABLE IN BARN NO. 2; TWO ROWS OF COWS TAILED TOGETHER. THE BARN IS CLEANED BY DRIVING AROUND BEHIND THE COWS.

Capacity, 75 cows in 2 rows, tails together, 51 head in outer circle, 24 head in inner circle.

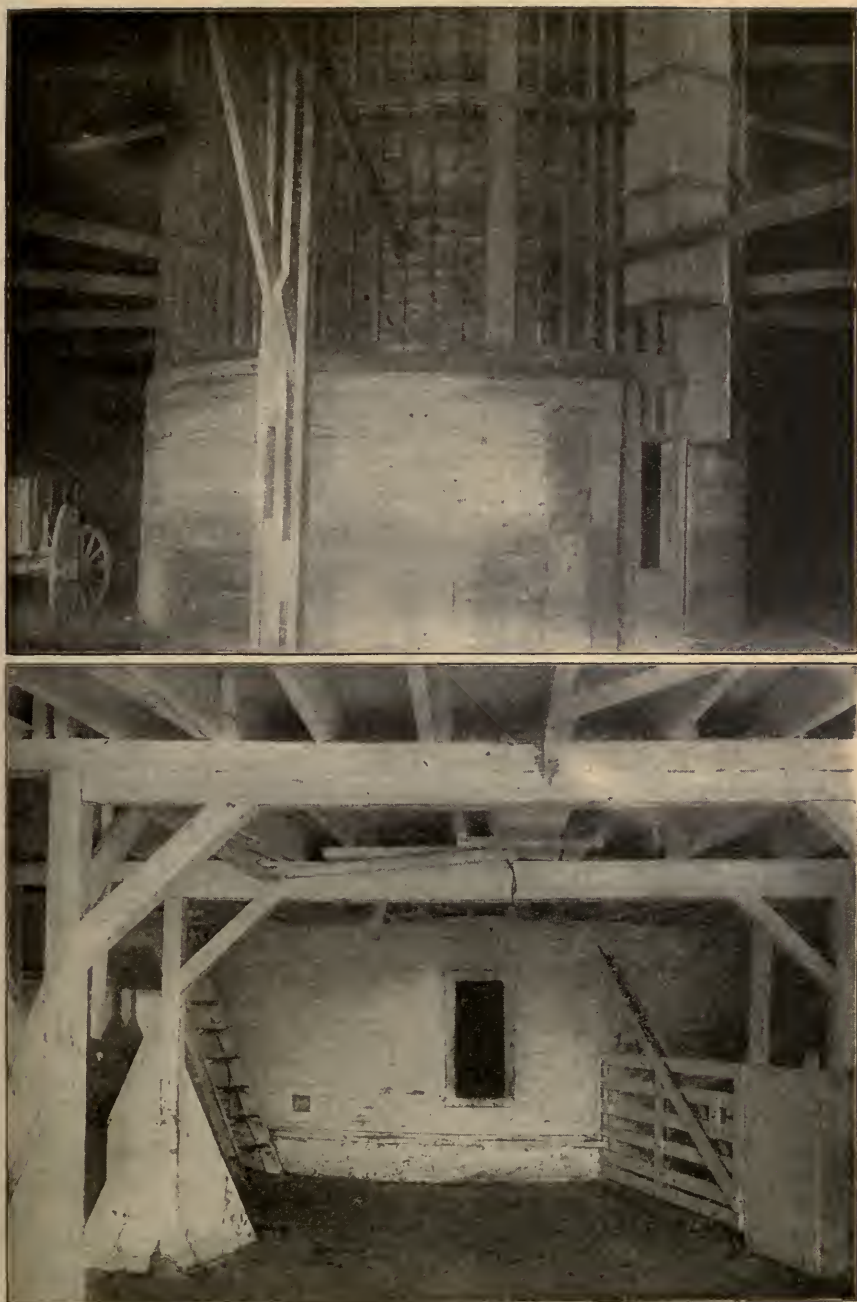
FIG. 31. SILO IN CENTER OF BARN NO. 4; UPPER PORTION IN HAY LOFT, LOWER PORTION IN COW STABLE.

Silo, round; diameter, 24 feet over all; height, 53 feet, exclusive of 12-foot space for water tank on top; capacity, 500 tons.

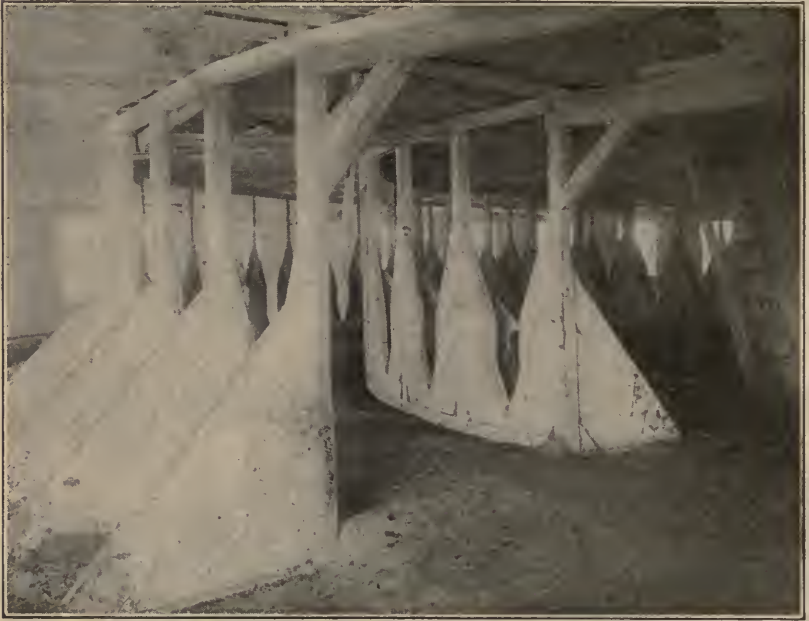
FIG. 32. INTERIOR OF BARN NO. 4, SHOWING STALLS AND FEED ALLEY.

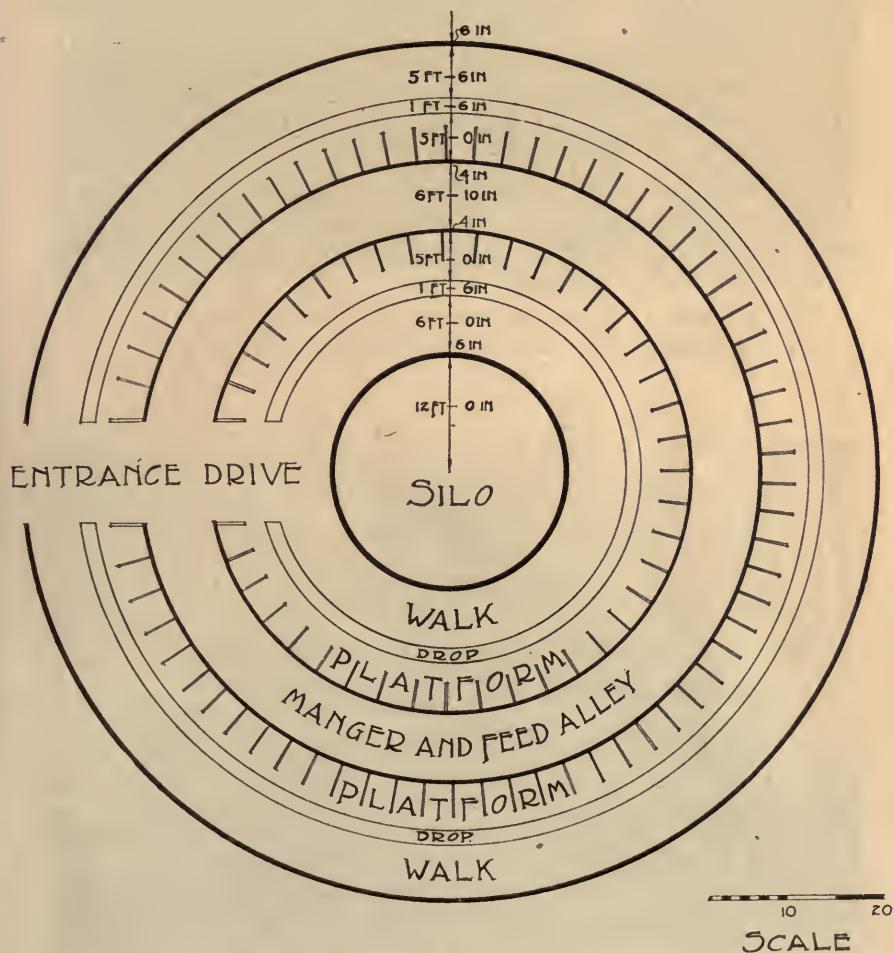
FIG. 33. ARRANGEMENT OF COW STABLE IN BARN NO. 4, 90 FEET IN DIAMETER;
TWO ROWS OF COWS HEADED TOGETHER.

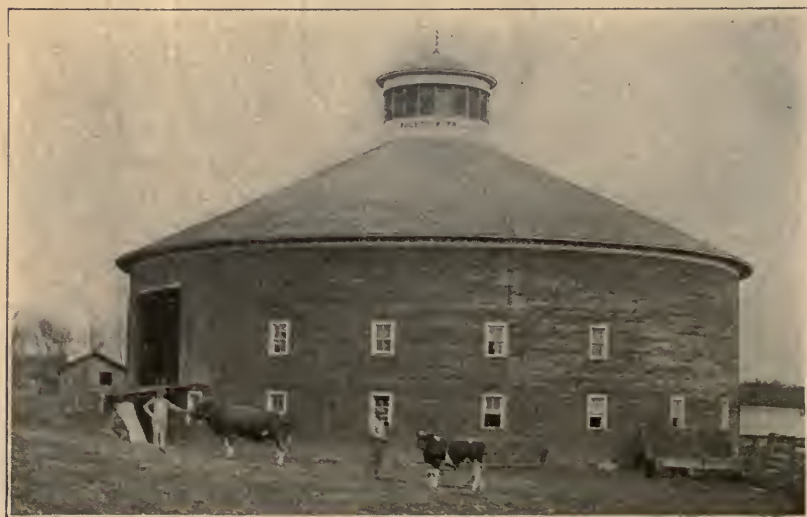
FIG. 34. BARN 92 FEET IN DIAMETER; TWO ROWS OF COWS HEADED TOGETHER; SILO IN CENTER.

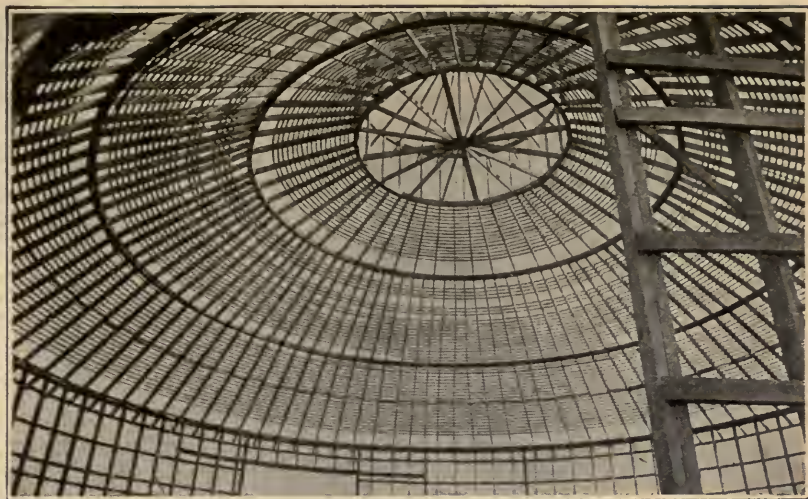
FIG. 35. VIEW OF 70-FOOT SELF SUPPORTING ROOF ON BARN SHOWN IN FIG. 36; NOTE HOOPS ON STUDS IN RIGHT FOREGROUND.

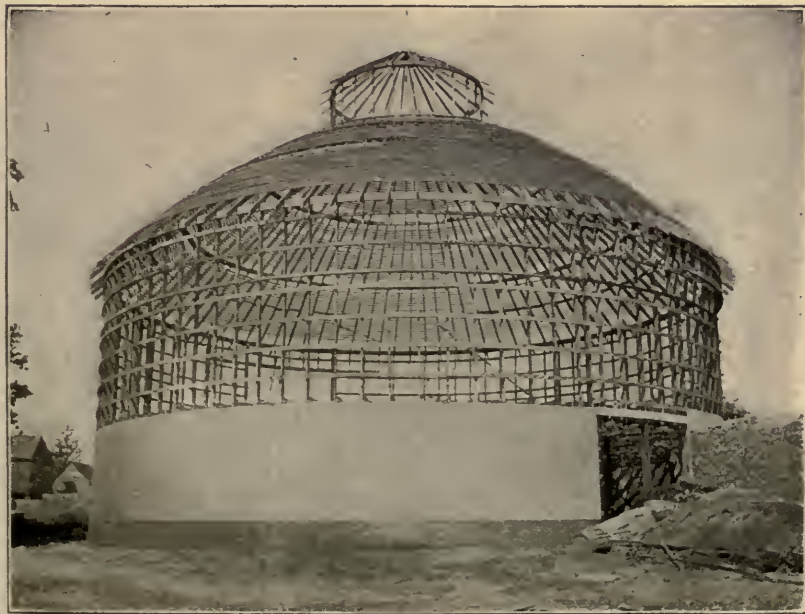
FIG. 36. BARN 70 FEET IN DIAMETER; FRAME HOOPED FOR PERPENDICULAR SIDING; LOWER SECTION SIDED.

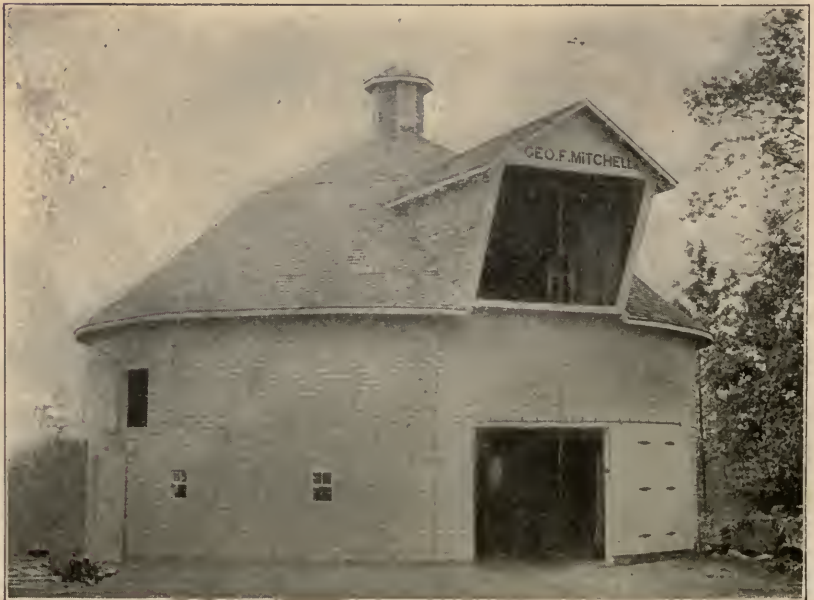
FIG. 38. BARN 48 FEET IN DIAMETER, 16-FOOT POSTS; NOTE METHOD OF TAKING HAY INTO SMALL, ROUND BARN.

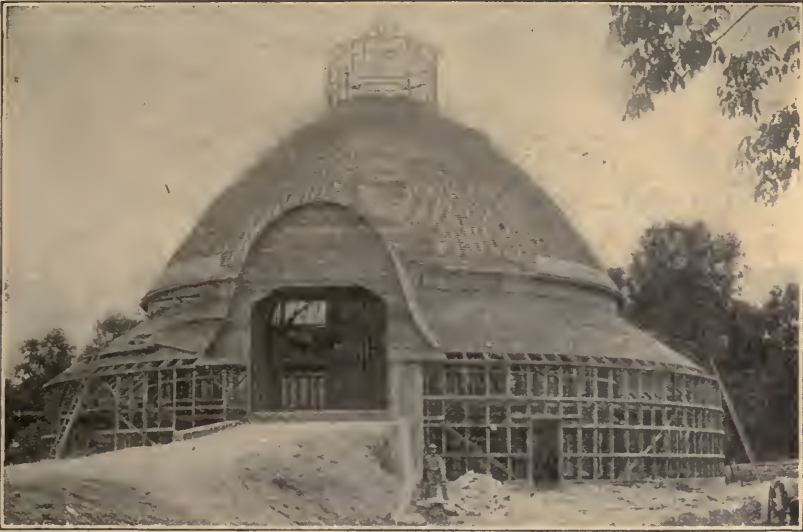
FIG. 39. SHOWING CONSTRUCTION OF BARN IN FIG. 40. HOOPS IN PLACE READY FOR PERPENDICULAR SIDING; ROOF SHEATHED FOR SHINGLES.

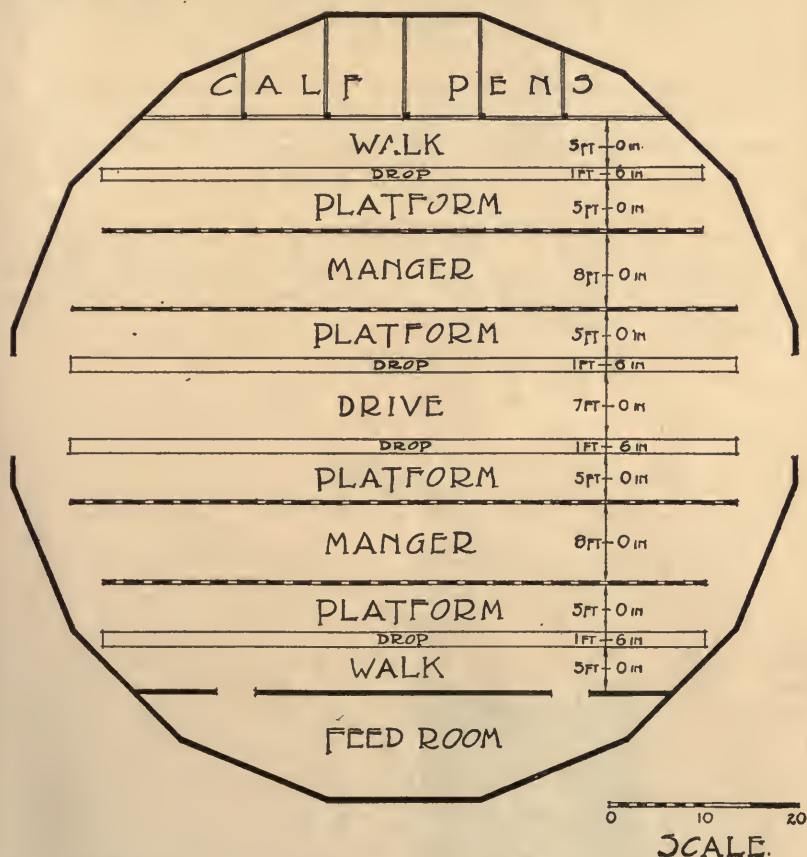
FIG. 42. ARRANGEMENT OF COW STABLE IN BARN NO. 6.
